Confirmation of Diagnosis

Exhaust Valves Phase Shift

Summary - This document consists of the report of detection and verification of the failure of an exhaust valve in a Waukesha P9390 GSI engine with 4000 running hours. The engine was monitored with Windrock technology, the results were analyzed by detecting a phase shift in the closing signal of the exhaust valve.

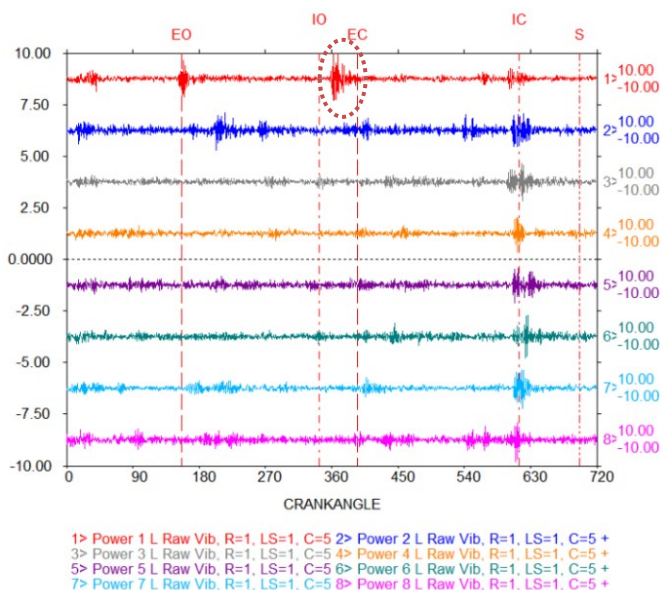
Graph 1: Measurement Ref 1: Vibrations Raw (unfiltered) in drive heads L, cylinder 1L (red), sensor in vertical direction respect to piston displacement direction.

The measurements corresponding to both previous graphs were collected with a temporary time gap of 5 months. By not performing the maintenance suggested by the Consultant after the first measurement (Graph 1), it is corroborated that the magnitude of the vibrations in the exhaust valve increases when the second measurement is made (Graph 2).

Cil 1L the signal of the closing of the exhaust valve is observed out of phase, we suggest to check valves clearance and inspection of hydraulic tappets.

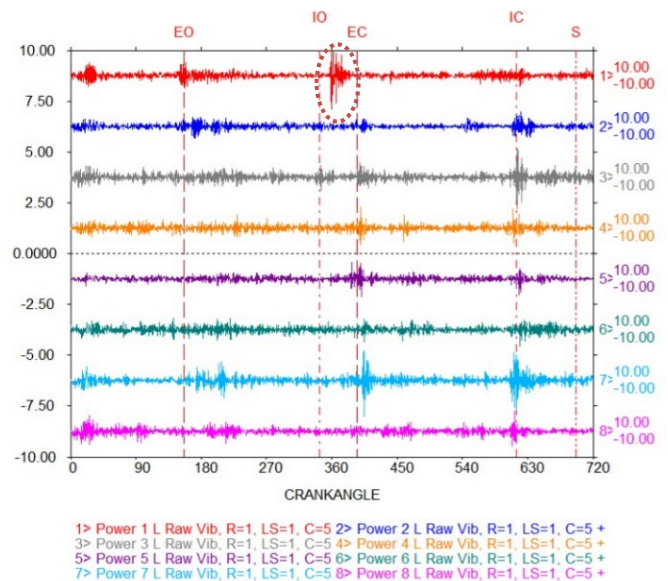
Graph 2: Measurement Ref 2: Vibrations Raw (unfiltered) in drive heads L, cylinder 1L (Red), sensor in vertical direction respect to the movement of the piston.

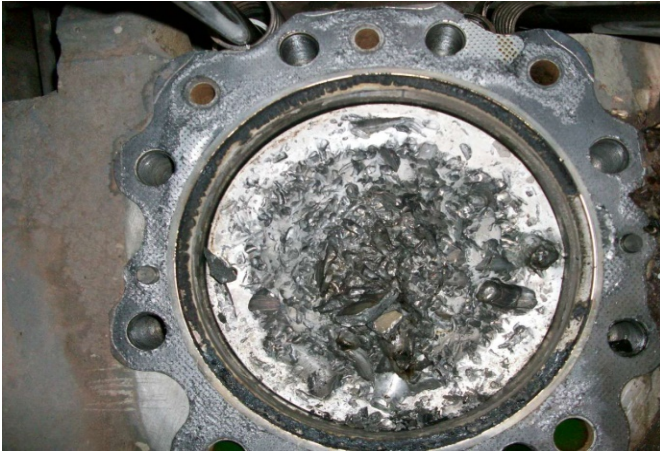
Because the engine continued the service knowing the existence of the valve phase shift and without taking preventative actions, the exhaust valve shaft is finally cut off. In figures 1 and 2 it can be visually verified that the diagnosis obtained from the previous measurements made and the corresponding analysis was adequate.

Picture 1: Piston & block face.

Faced with the destruction of the components, the costs of repair of the engine included the following items, where the construction parts were replaced in their entirety

- Cylinder head
- Liner
- Piston
- Air inlet turbo-compressor
- Engine oil replacement and carter cleaning
- Valves
- Manpower cost for complete repair
- Non-Production Operative cost for the compression unit hours stopped.

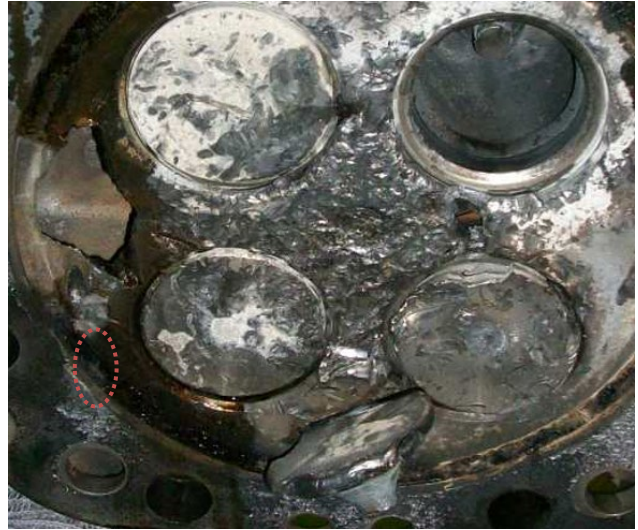
Picture 3: Cylinder head – Exhaust valve head

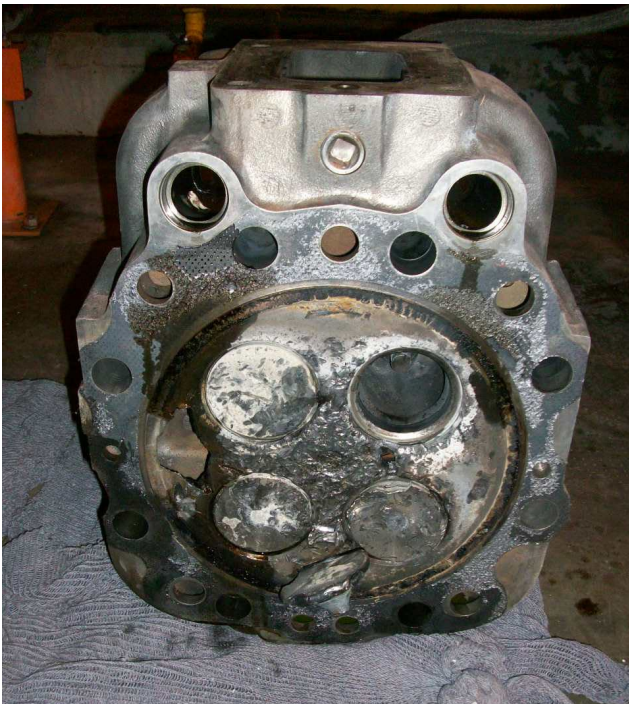
Picture 2: Cylinder head

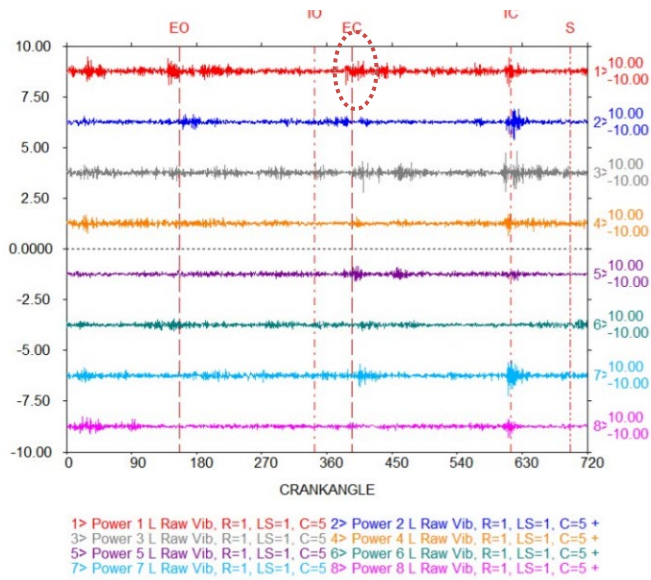
Graph 3: Vibrations Low Freq in cylinder banks drive L

After the complete change of the equipment, the correction of the time lag in the closing of the exhaust valve of cylinder 1 of bank L is verified by a new measurement.
